**Engineering Assessment of Two Cylinders Observed at the Douma Incident****- Executive Summary**

DRAFT FOR INTERNAL REVIEW  
Expanded Rev 1 - 27 February 2019

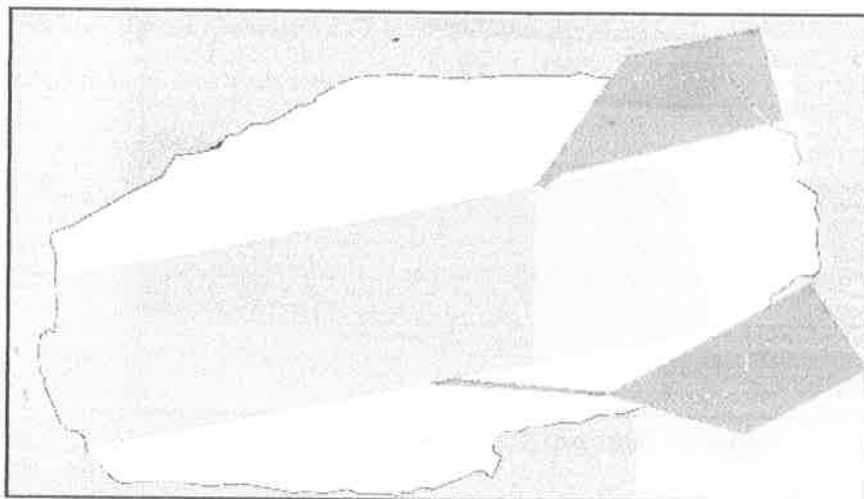
10. The key observations at Location 2 were the cylinder, which showed a specific mode and extent of deformation, and the crater. Critical elements of this study were identified as (1) cylinder deformation, (2) the size, shape and characteristics of the crater, and (3) a relative comparison of the cylinder and crater, i.e. was there the match of an assumed impact between the two?

Figure 10: Location 4 cylinder post-impact superimposed onto crater, from dimensional model

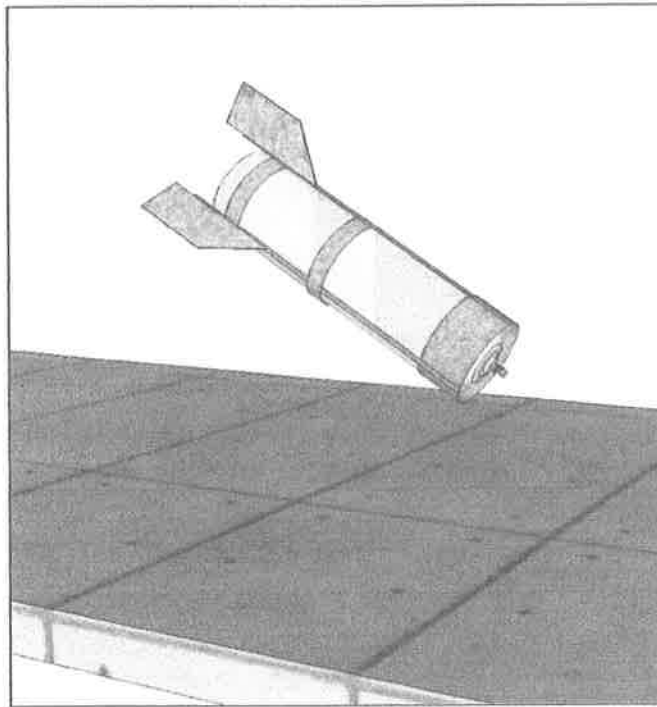
Figure 11: Test case - nose-down angle of incidence

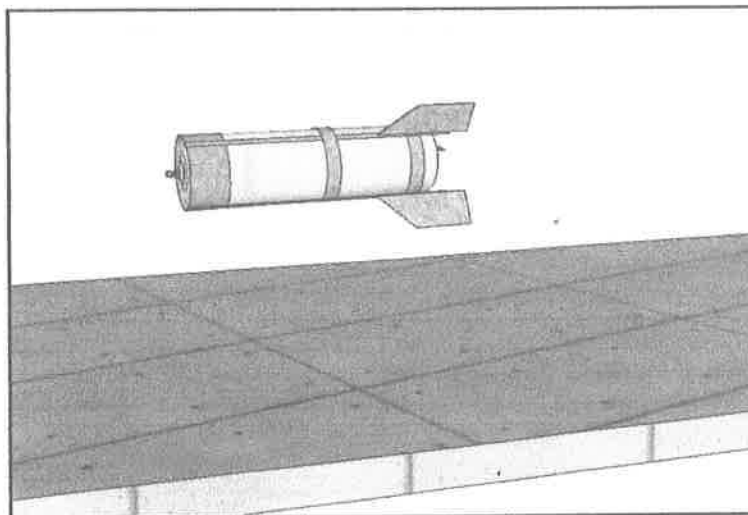
Figure 12: Test case - horizontal angle of incidence
